December 9, 2020

Re: **Bixby Road & Ebright Road Traffic Study Letter Report**

IBI Group is pleased to submit this letter report for the traffic study conducted at the intersection of Bixby Road & Ebright Road in the City of Groveport. The City of Groveport initiated this study after citizen inquiry.

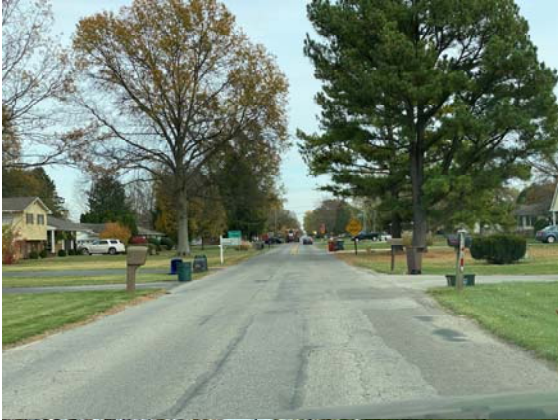
Bixby Road Eastbound

The stop ahead sign is located about 350-ft west of the stop bar under a pine tree. The pine tree provides shade on bright days, making the sign less visible.

- Install a new single 48" W3-1 Stop Ahead sign on each Bixby Road approach; these signs should be placed about 565 feet from each Stop Bar. The sign locations should be adjusted as necessary to avoid driveways, intersections and close proximity to other signs. The bottom of the sign should be 7 feet vertically from the adjacent edge of pavement per OMUTCD requirements.

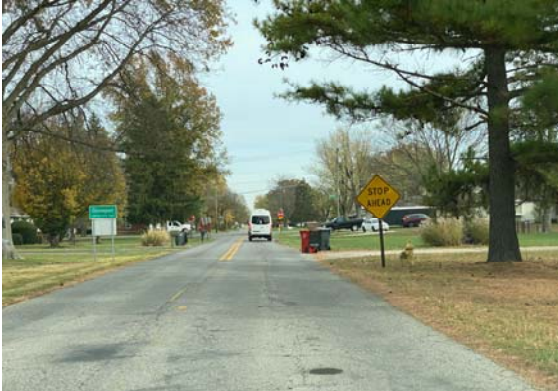
The stop ahead sign located under the tree may be mounted slightly lower than recommended.

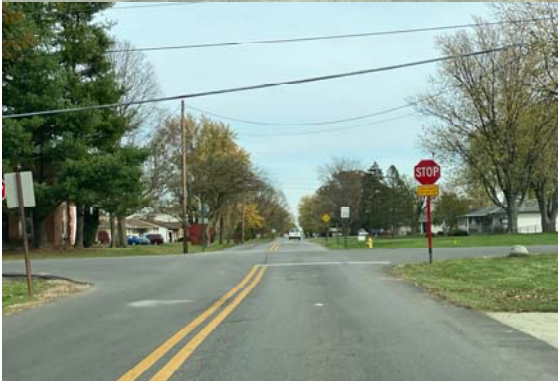
The stop bar and stop sign are readily visible to approaching drivers.

- Install new dual 48" Stop signs (with Solar LED flashers on the right-hand sign only) on each Bixby Road approach. Vertical reflector panels should be installed on the sign supports. The bottom of the signs should be 7 feet vertically from the adjacent edge of pavement per OMUTCD requirements.

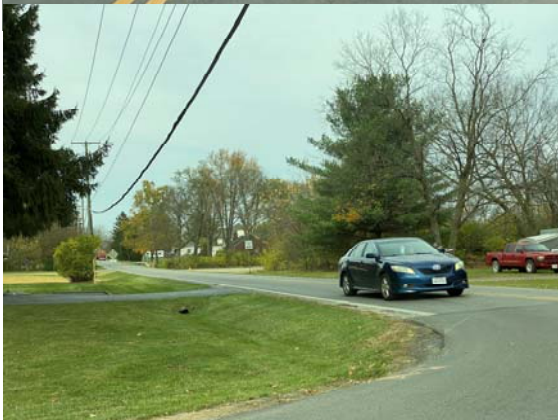
Sight distance to the north from the eastbound stop bar is shown in this picture. The sight distance is the most important view based upon the crash data for this intersection. The bush located next to the utility pole may slightly restrict an eastbound driver's cross-corner sight distance to the north.

- Remove or prune any bushes, trees or other vegetation within the public right of way along Ebright Road in both directions from Bixby Road, especially the bush adjacent to the utility pole on the east side of Ebright Road about 225 feet north of Bixby Road.

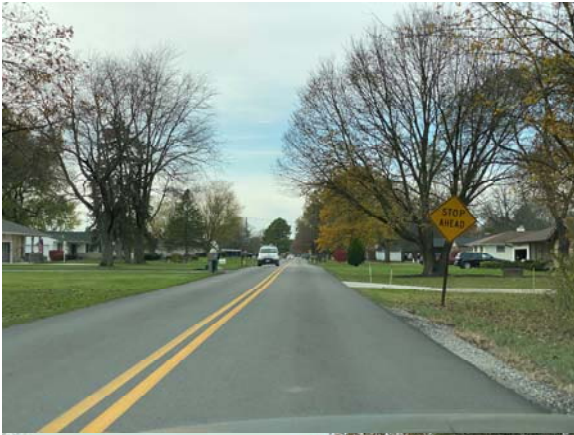
Bixby Road Westbound

The westbound stop ahead sign is located about 680-ft east of the stop bar.

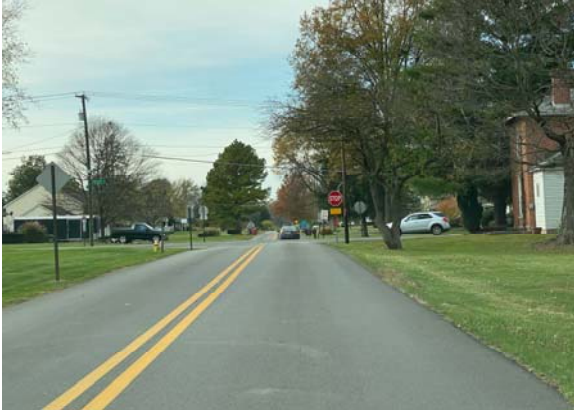
The westbound stop bar and stop sign are readily visible to approaching drivers.

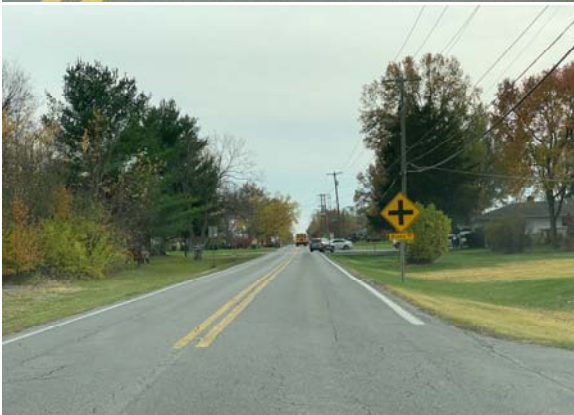
Ebright Road Southbound

The southbound crossroad warning sign is located about 320-ft from the intersection and includes a Bixby Rd name plaque.

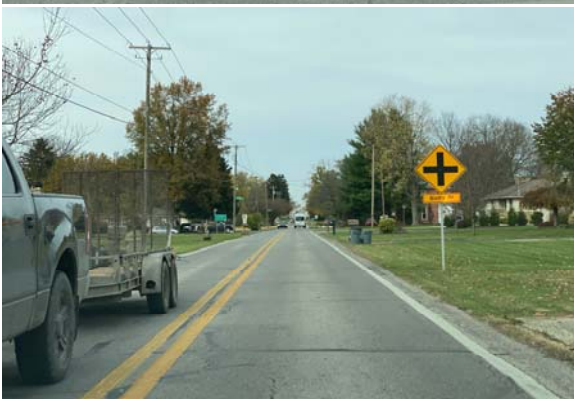
Ebright Road Northbound

The northbound crossroad warning sign is located about 360-ft from the intersection and includes a Bixby Rd name plaque.

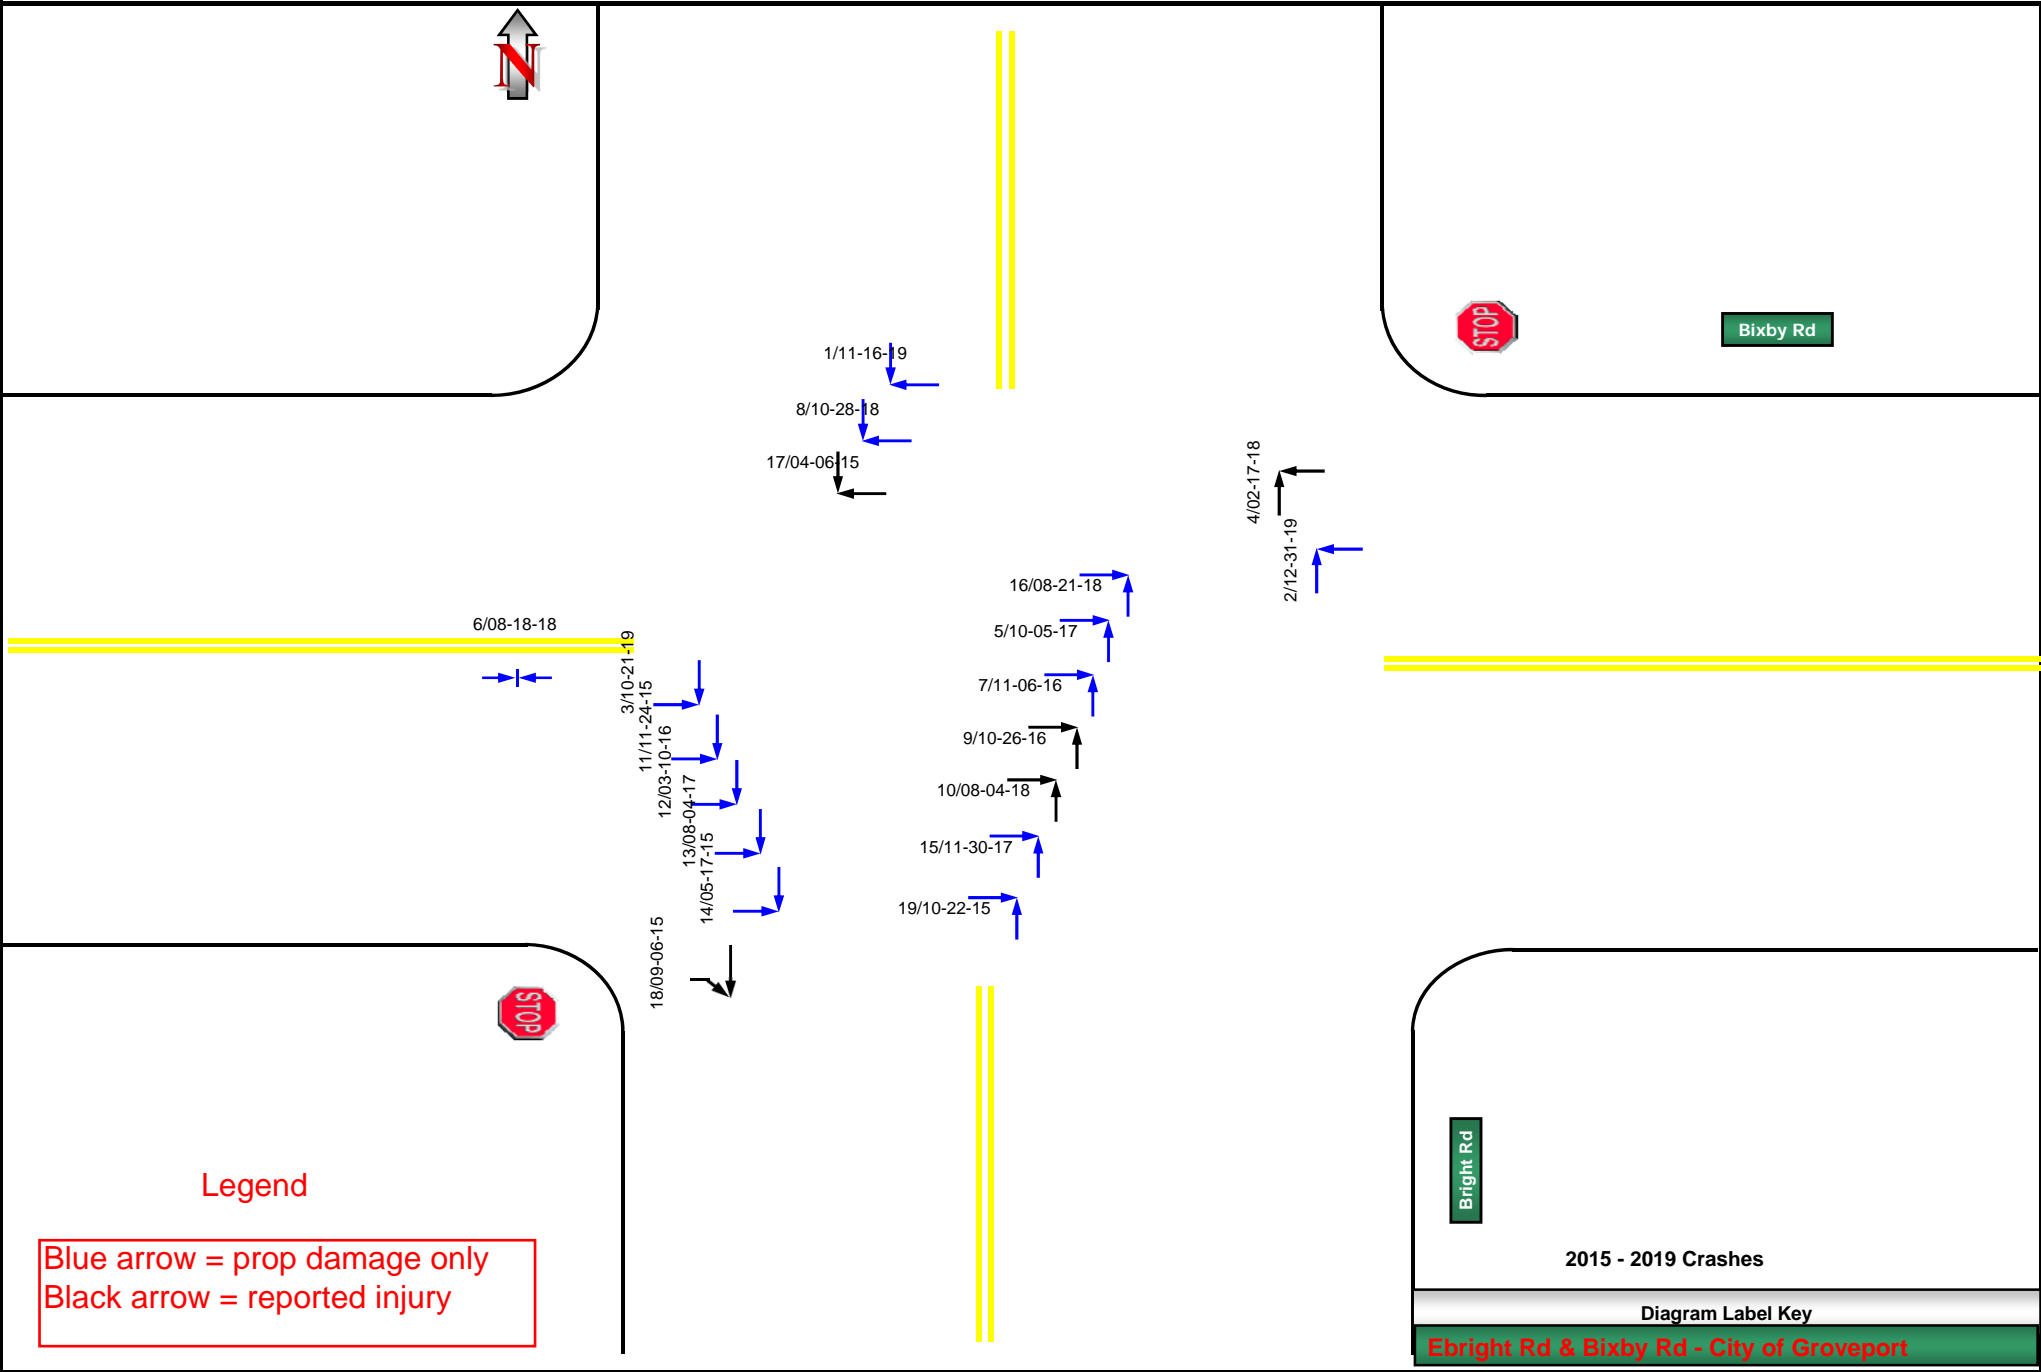
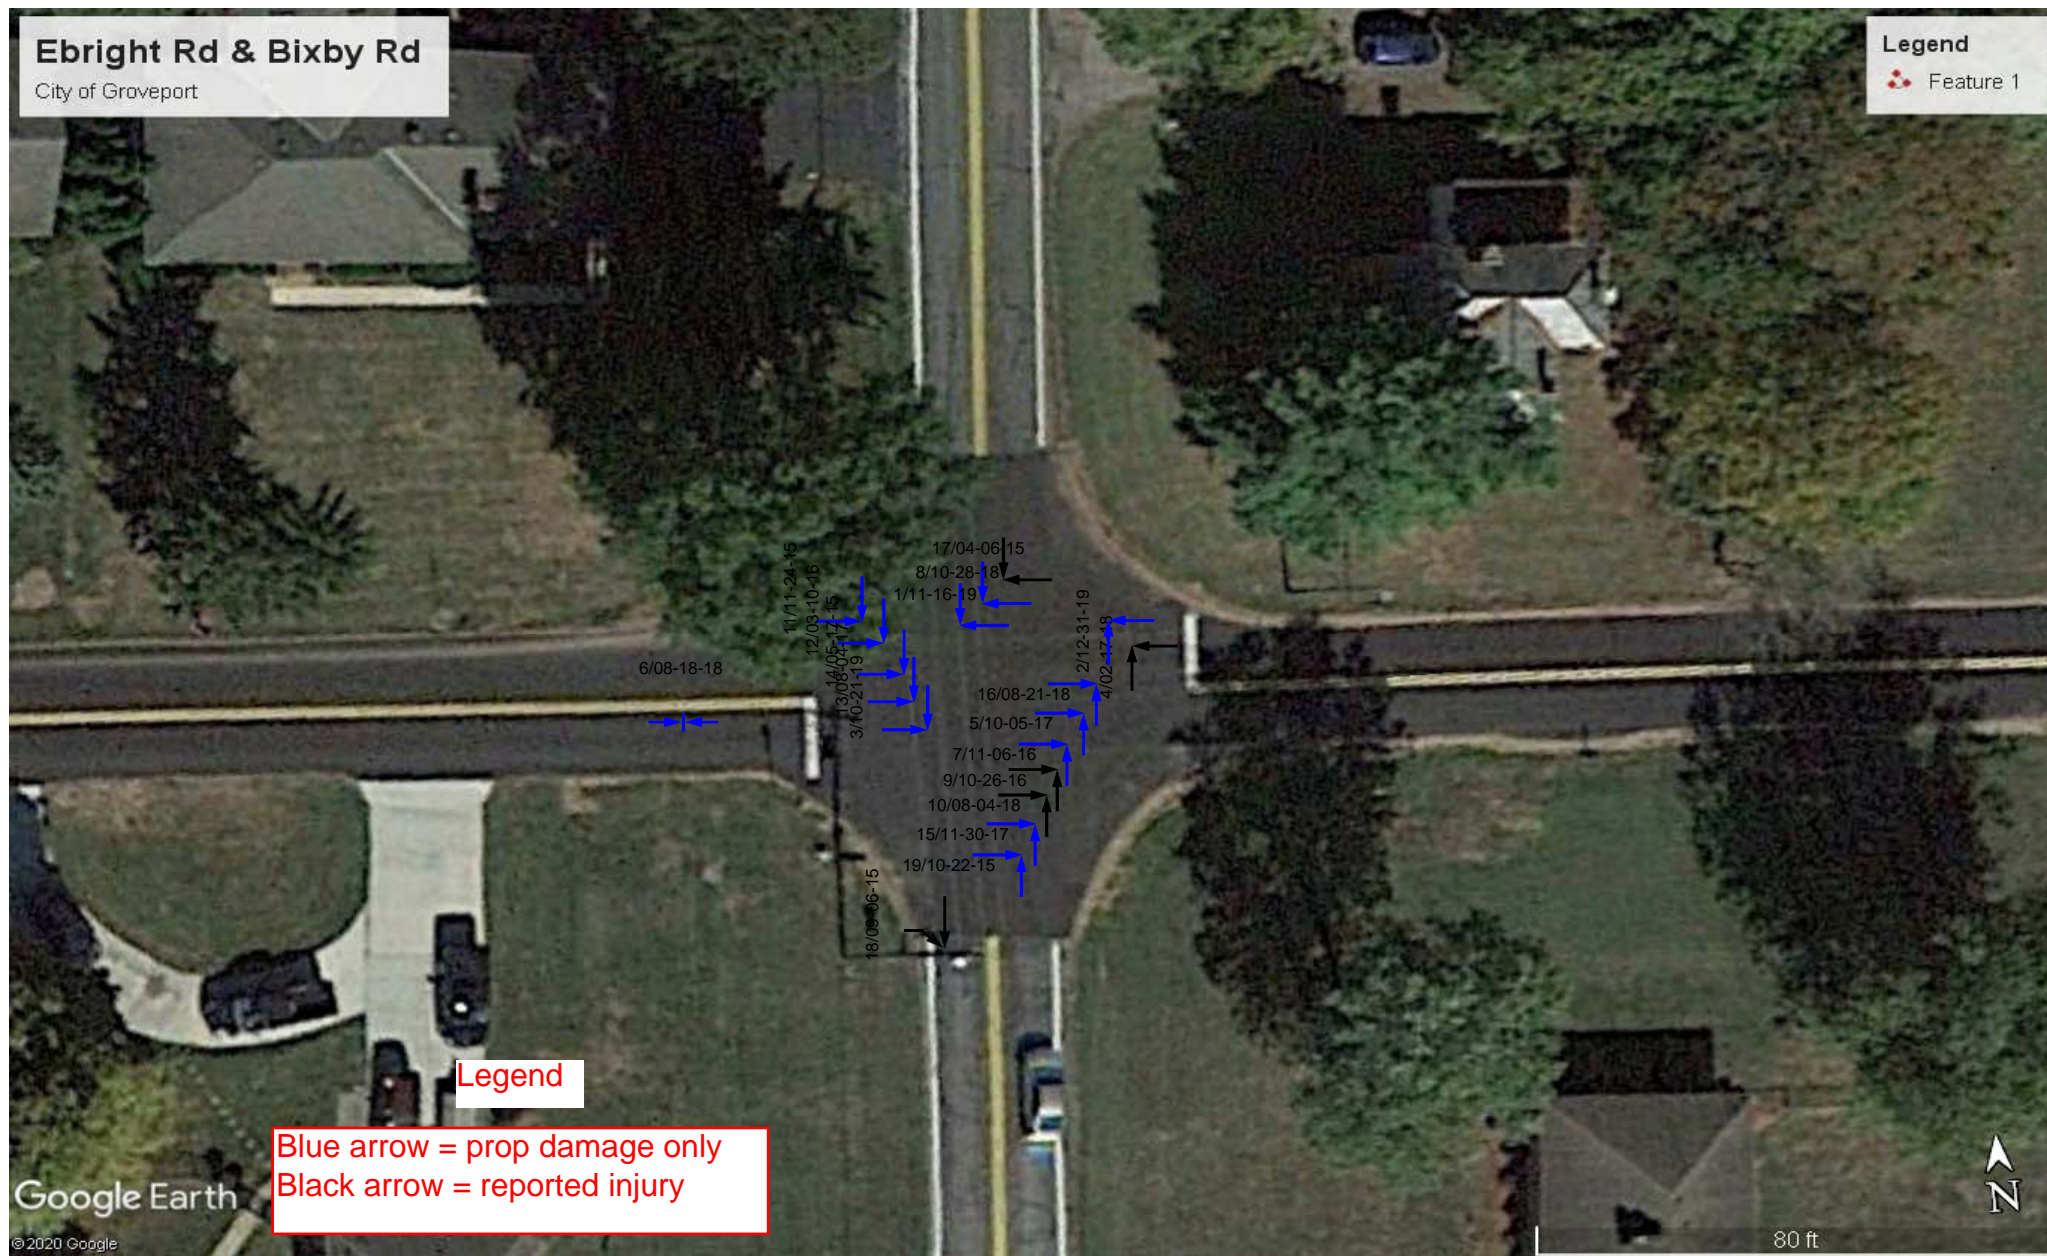
Exhibit 1A

Exhibit 1 shows an intersection crash diagram using 2015-2019 crashes. The most noticeable pattern in the crash diagram is that 12 of the 19 crashes were angle crashes which involved an eastbound vehicle

on Bixby Road. Of these 12 angle crashes, the other vehicle was southbound in five cases and northbound in seven cases. There were five other angle crashes on Bixby Road which involved a westbound vehicle colliding with a southbound vehicle in three instances and a northbound vehicle in two other instances.

Over the five-year 2015-2019 period, the typical crash at this intersection was an angle crash which involved an eastbound driver and injury and occurred on a weekday, in daylight conditions, on dry pavement and between the hours of 3:00 and 7:00 PM in the afternoon/evening (69% of crashes). August, October and November had the most crashes. Because these afternoon angle crashes typically involved an eastbound driver on Bixby Road, poor stop sign visibility caused by the setting sun in the west was presumable not an issue.

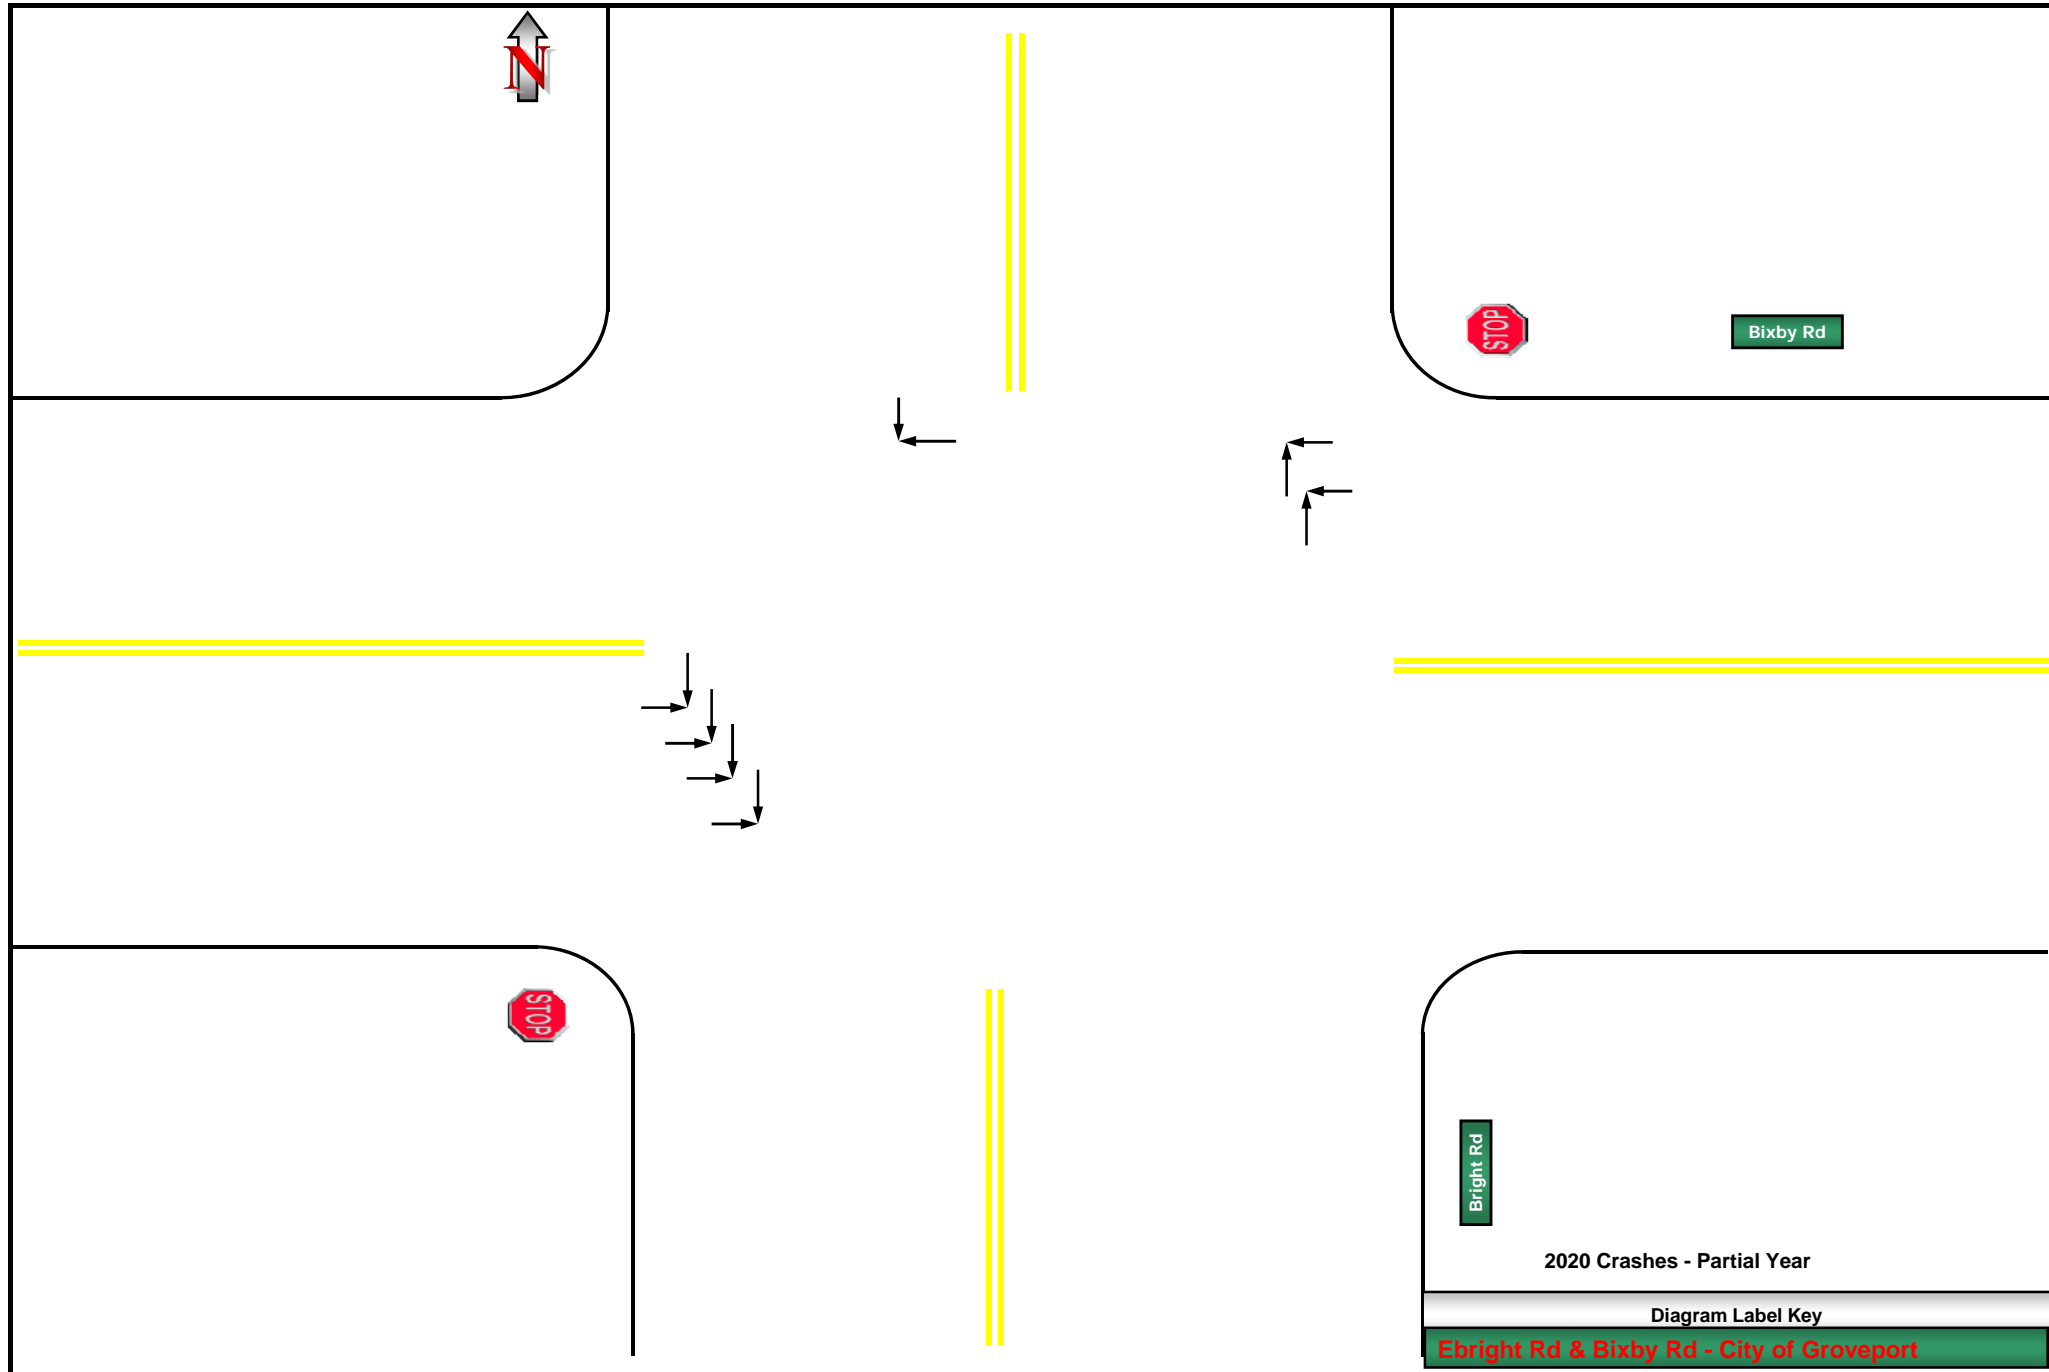
Exhibit 2

Exhibit 2, the 2020-only crash diagram, shows a pattern consistent with the 2015-2019 pattern. The most prevalent angle crashes (four of them) in 2020 involved an eastbound vehicle colliding with a southbound vehicle. There were also three angle crashes involving a westbound vehicle. Two of these occurred with a northbound vehicle and one occurred with a southbound vehicle. Six drivers were cited for failure to yield and one for failure to stop.
